GLEASON LIBRARY STUDY

Existing Conditions & Treatment Recommendations

Prepared for the:
Town of Carlisle

August 1, 2019

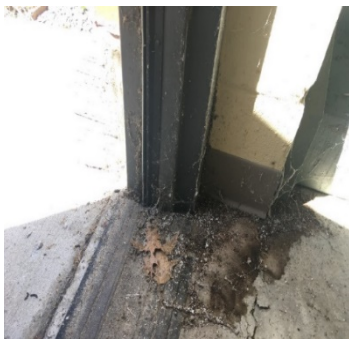
Threshold at rear egress door with damaged concrete slab.

Treatment Recommendation: We recommend cleaning the damaged area of the slab, repairing the cracks and other disintegration and resealing it.

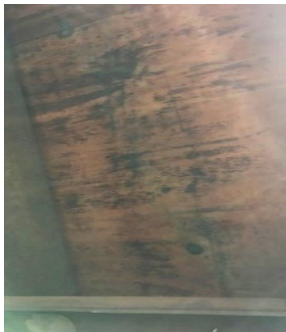
Mildew growing on plywood of roof deck over gabled entrance.

There are two small gabled areas over the east and west entrances of the addition. We were able to observe the wooden rafters and decking from the interior of gabled area. We noted that these areas are not vented properly, and that mildew is present on the plywood decking.

The condition of the structure under the asphalt roof at the gabled entrances is in fair condition. The rafters are good, but the plywood decking has mildew growing on it and some warping is observed. If the plywood decking is damaged it should be replaced; otherwise it should be treated for mildew.

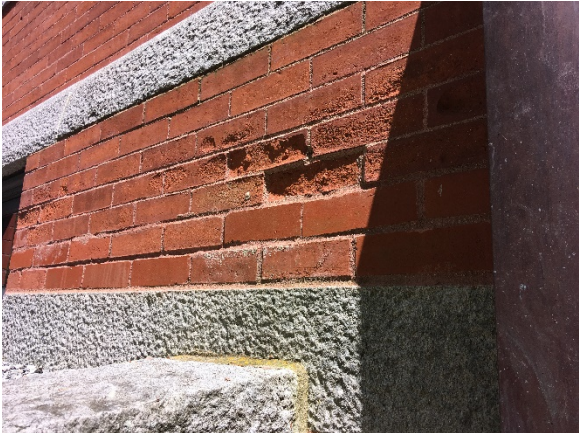
Figure 14 - Spalling bricks SW corner of original building.

spalling in the bricks on the SW corner. The granite sills on the north side are beginning to host mildew in various places. We did not observe the interior conditions anywhere within the walls. Cold spots are reported within the interior spaces, especially on the second floor, which may be due to poor air distribution or thermal losses through the walls. However, without destructive investigation we could not verify insulation within the walls. The interior walls are finished in either a wooden lath covered in plaster or in gypsum board. Overall the condition of the walls is good. Walls are finished in paint, wood trim, or tile. We noted paint peeling in the north egress stairwell, and the stairwell between the second and third floors, and the west wall of the third floor.

B2010 Exterior Walls: The granite areas of the north side of the building should be cleaned to discourage mildew from growing and prevent associated problems from developing. The spalling brick on the SW corner should be replaced with intact brick and the cause of the spalling should be further investigated. If the condition is not determined to be due to moisture migration from the interior, the existing bricks may be protected with an application of an appropriate protective coating. The caulking at the expansion joint

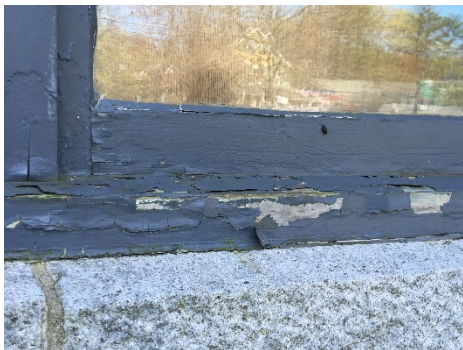
2000 Addition: All window frames, which are all metal, appear to be in good condition and housing operable windows. We note that there are openings in the corner miter joints. We note that there are no weep holes between the bottom of the window frame and the sill is sealed with caulk. The sashes appear to be in good condition and operating.

2000 Addition: Caulk where the window frames have separated at the corner joints. Remove caulk at the sill.

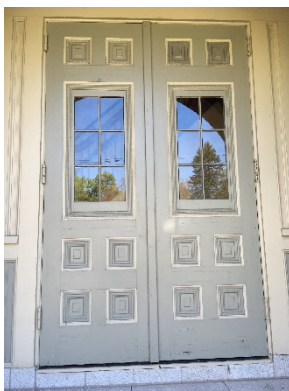
North Egress Doors

The North egress doors (the original main entrance) are wood and glass and the South egress door is metal. The North egress door (formerly the main door) is dirty. The South egress door is rusting and sticking and is not completely sealed at the bottom. This has led to water infiltration which has damaged the concrete slab in the Southeast corner as noted in the previous section.

Egress Doors: The south egress steel door and frame should be scraped free of rust, primed and painted. Alternatively, due to the damage already suffered, consider replacement of the door and the frame. Add an exterior surface mounted sweep to prevent water from entering. The north egress door and alcove area should also be cleaned.

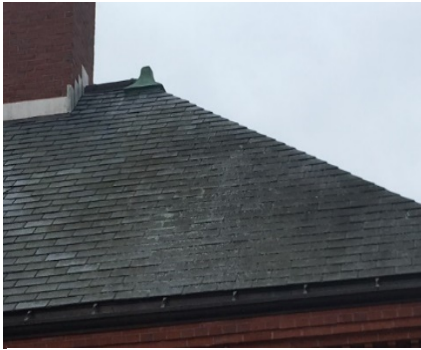
Lichen growing on north side of slate roof.

Original Building: The slate roof on the original building is in generally good condition after the envelope restoration project in 2010. The slates are in good condition on three sides. On the north side (front), the slates are becoming a home to lichen. Some shingles have become loose and have fallen. We observe that the flashing around the plumbing vent is displaced. The step flashing on the chimney appears to be in good condition however our observation is limited to what can be seen from the flat roof. With the same caveat about our access, the flashing in the hips, ridges, and valleys appears to be in good condition. The gutters appear to be in good condition. Many of the copper downspouts have failed, with the vertical seams (facing the building) on the back side have opened. This may be due to ice buildup starting at the base and expansion up the downspout.

Original Building: We recommend yearly inspection and maintenance of this roof. Presently, replace the slate shingles that have fallen, check the flashing around the plumbing vent and other areas. When the roofing is replaced on the addition, we recommend removing the slate and asphalt shingles for about two feet and carrying membrane up where the shingles meet the flat roof to accommodate snow drifts and/or buildup during the winter.

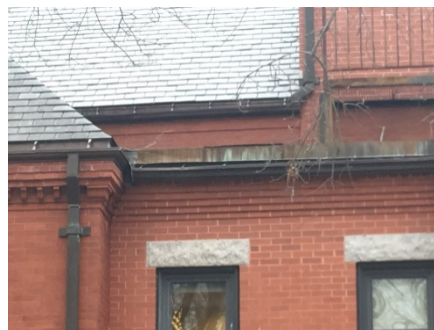
Damaged gutter and flashing on west elevation of flat roof.

although we could not observe this directly. There is damage to the gutter and the flashing on the west side of the building. The

gutter and flashing are bent. The copper downspouts have failed as noted above, with the vertical downspout seams in the back expanded and opened.

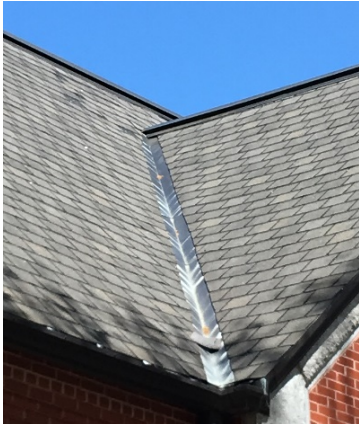
Asphalt shingles rippling and falling in roof addition.

Asphalt Roof: The asphalt shingles are twenty years old and are nearing the end of their useful life. Many shingles are rippling, particularly along the top courses on the south (rearmost) face of the building. A few have slipped off. Roof ventilators along the lower roof courses on the North face of the addition (abutting the flat roof) which were original to the design have been covered with asphalt shingles.

Asphalt Shingle Roof: This roof covering is near the end of its life. The shingles are warped on the southern exposures, which may be due to the lack of ventilation. While the flat roof is replaced, this roof should be investigated further to determine whether it should also be replaced. As discussed, the flashing for the flat roof should extend two feet up from the flat roof. This roof also needs to be better ventilated. The ventilation system that was taken out needs to be restored. Methods of ventilation should be explored in detail when the roof work is commissioned. Any ventilation should be raised up from the flat roof, so it does not become blocked with the snow in winter.

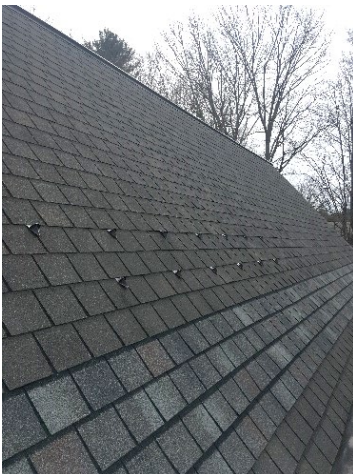
Four courses of shingles which replaced venting on roof of addition.

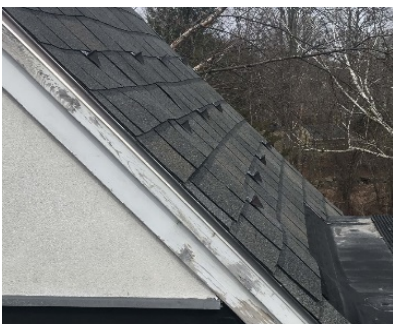
Rippled asphalt shingles on entrance gables.

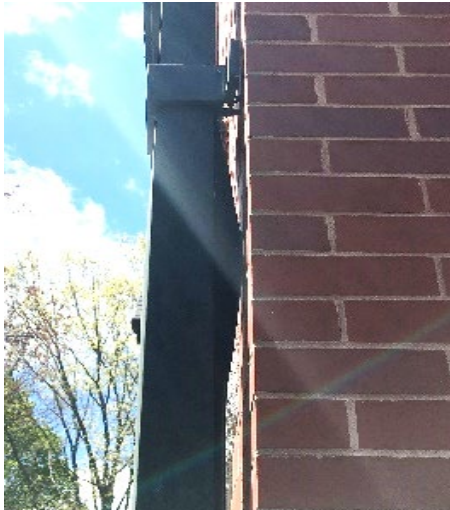
Open seam at back of downspout.
