GLEASON LIBRARY STUDY

Existing Conditions & Treatment Recommendations

Prepared for the:
Town of Carlisle

August 1, 2019

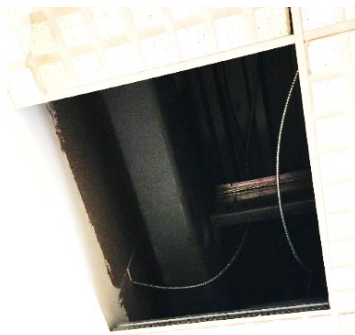
View of Beams and Decking in Addition

five inch floor slab, which sits on six inches of compacted gravel. The slab is covered in carpeting and cannot be seen. From what we could observe, the floor slab does not show any signs of settling or cracking. The only place where we observed damage to the slab is inside the egress area of the stairwell in the rear of the building. The upper floor of the addition (at the level of the first floor of the original building) is framed with steel beam with steel decking and a poured concrete floor. We were able to see a glimpse of it when one of the ceiling tiles was removed. It appears to be in good condition.

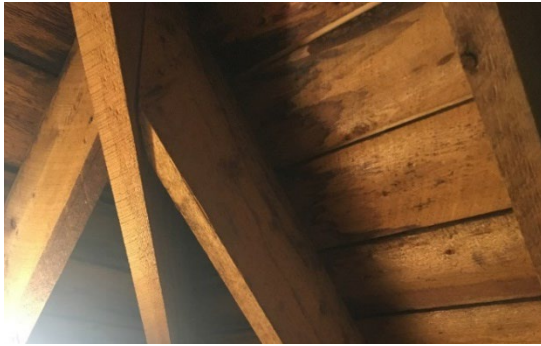
Rafter and boards of original roof seen from attic in original building.

The slate roof was significantly restored and repaired in 2010, during the Envelope Restoration and Repair Project. At that time, the slate shingles were removed, the disintegrated weather barrier was removed (felt), and damaged roof decking was replaced.

A new weather barrier was installed and original shingles in good condition were reused, others were replaced. Although staining can still be seen from the interior (not shown here), this is likely from water infiltration from over ten years ago, before the entire envelope was repaired. No dampness was observed now.

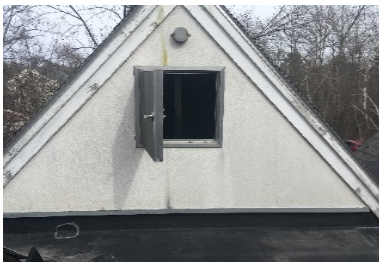
Gabled areas over main entrances in addition.

Addition (2000) – We cannot observe the steel structure and deck of the flat roof that connects the original building to the addition. We have reason to believe it is in good condition as no settling or movement is apparent. We observed a sample of it where a ceiling tile was removed and, in this area, it appeared to be in good condition.
